# **FINDING OF EFFECT MEMORANDUM (Revised)**

*Prepared by ICF at the request of Marin Housing Authority in partial fulfillment of Section 106  
Review requirements*

**July 14, 2020**

**Historic Property:** Golden Gate Village  
**Project Name:** 115 Drake Avenue Repair  
**Street Address:** 101–429 Drake Avenue and 1–99 Cole Drive, Marin City  
**Project Applicant:** Marin Housing Authority, County of Marin  
**Lead Agency:** County of Marin  
**Project Contact:** Evan Smith, esmith@marinhousing.org

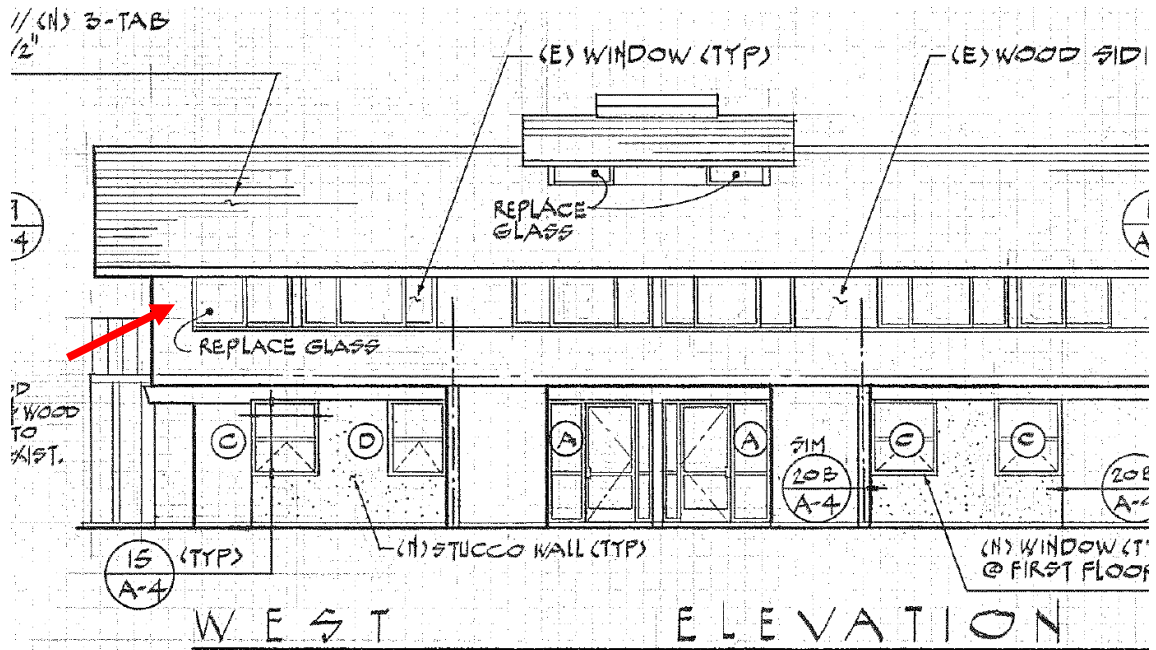
Figure 2: West (primary) elevation of building B-12 showing façade changes from 1985 remodel. Red arrow points to unit 115. Courtesy: MHA Archives, *Remodel-Building B-12 Marin City Housing Cal 52-1 Plans, sheet A-1, 1985.*

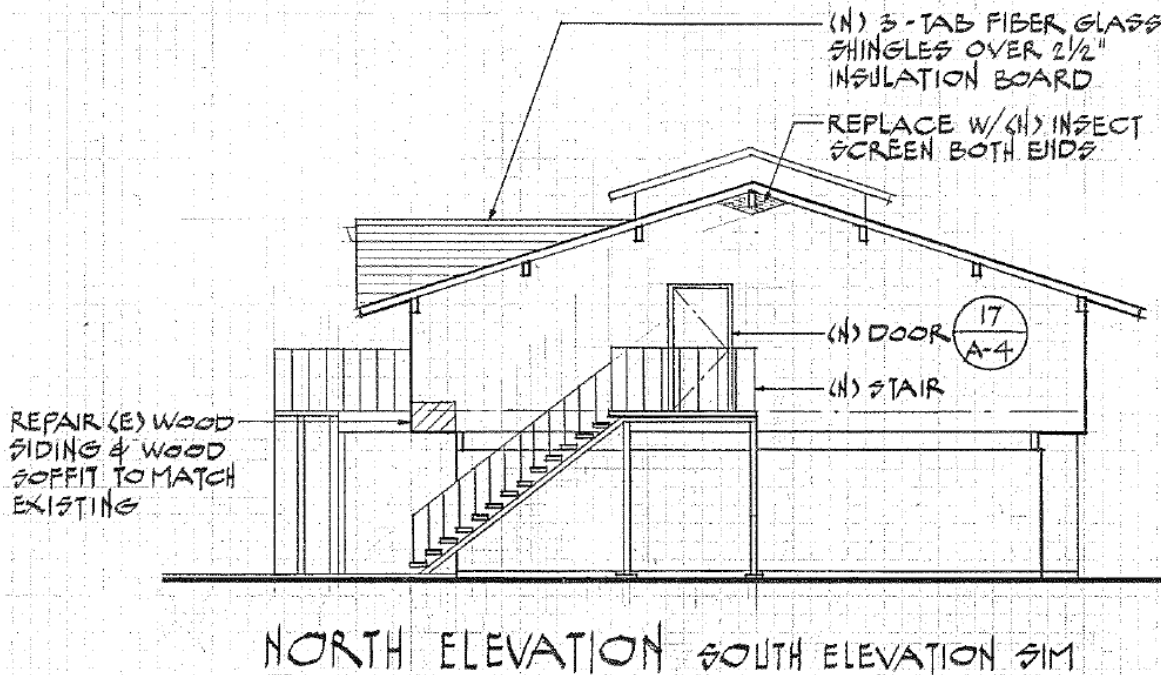
Figure 3: North elevation of building B-12 showing façade changes from 1985 remodel. Unit 115 spans the width of the building. Courtesy: MHA Archives, *Remodel-Building B-12 Marin City Housing Cal 52-1 Plans, sheet A-1, 1985.*

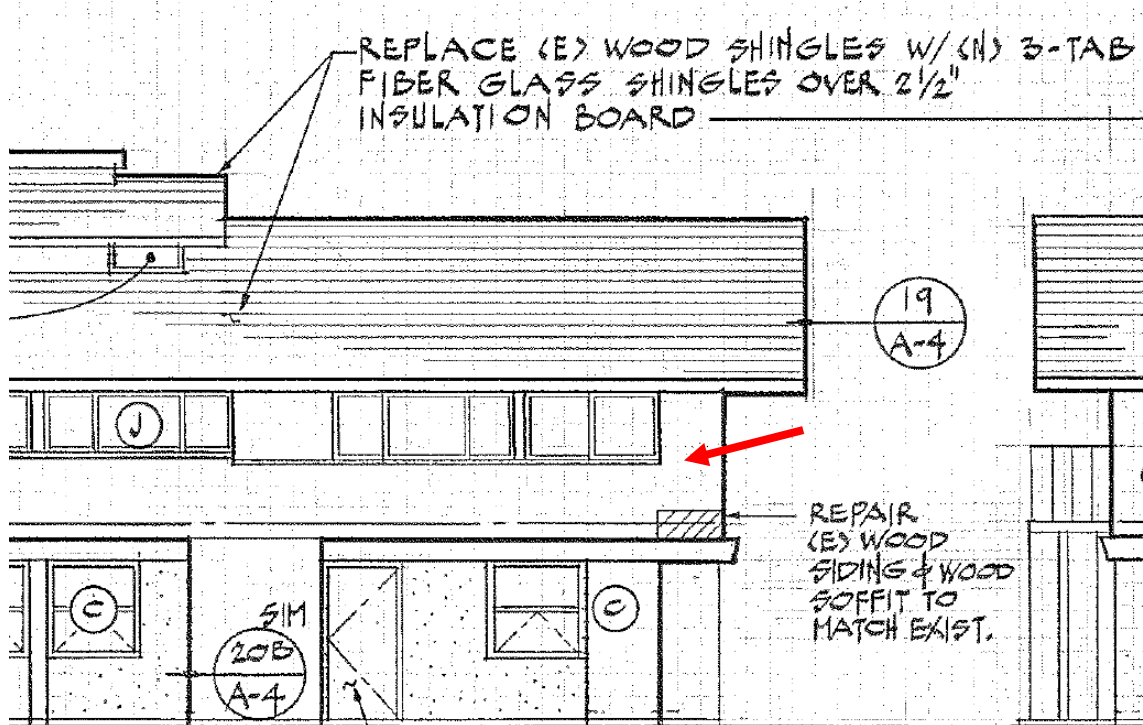
Figure 4: East elevation of building B-12 showing façade changes from 1985 remodel. Red arrow points to unit 115. Courtesy: MHA Archives, *Remodel-Building B-12 Marin City Housing Cal 52-1 Plans, sheet A-1, 1985.*

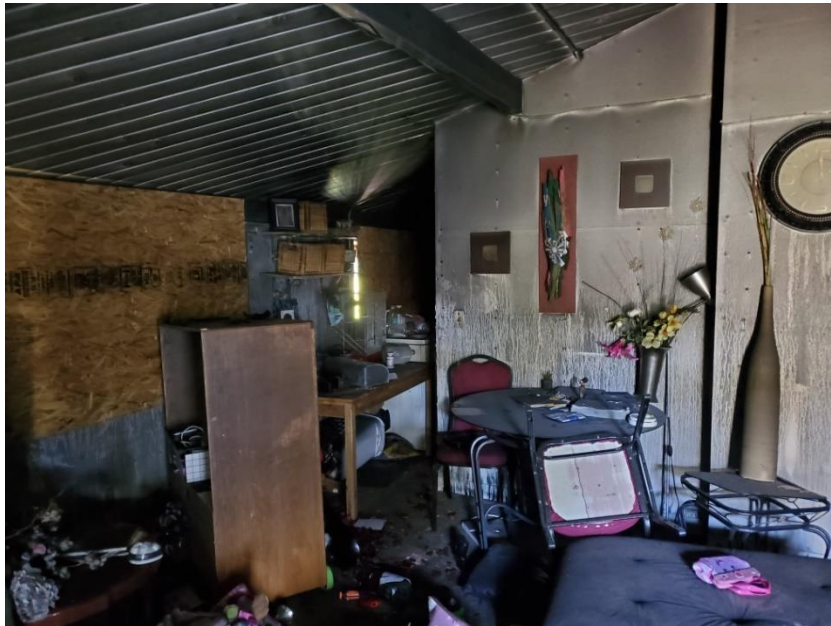
Fire and smoke caused damage to the interior of unit 115 (Figure 9). However, it also damaged the following exterior features: aluminum-frame slider windows on the building's primary (west) and rear (east) façades (Figure 10); part of the roof at the north end of the building (Figure 11); the pedestrian wood door and the staircase on the north façade; and redwood siding concentrated at the building's second story on the primary (west) and north façades at the building's northwest corner, and rear (east) façade at the building's northeast corner.

**Figure 9: Photograph of interior of unit 115, with smoke damage at the windows, building walls, and roof. Source: MHA, received by ICF on 5/19/2020.**

To repair the damage, Marin Housing Authority will undertake the following scope of work:

- Replace in-kind between eight and ten aluminum sliding windows at the second floor of unit 115, primarily located on the building's north end, the primary façade at the northwest corner, and the rear façade on the northeast corner (some of the windows were replaced in-kind in the 1985 remodel);

- Replace the pedestrian wood door on the north façade (1985 alteration);
- Repaint the staircase on the north façade (1985 alteration);
- Conduct patch repairs to the roof at the building's north end (1985 alteration);

- Conduct in-kind repairs to the exposed rafters at the roof, at the building's north end (historic feature);
- Replace in-kind the damaged redwood siding at the building's north façade, the primary façade at the northwest corner, and the rear façade at the northeast corner (portions of redwood siding replaced in-kind in the 1985 remodel); and

- Repaint in-kind the exterior of unit 115 at the primary, north, and rear facades (historic feature).

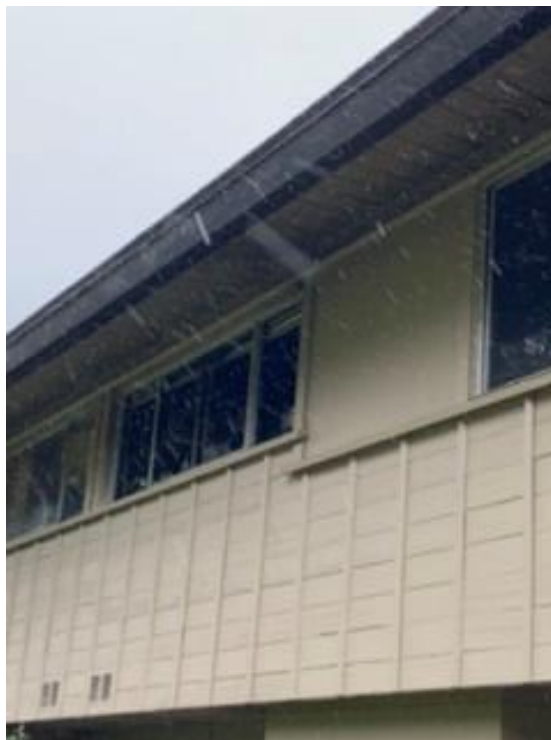
**Figure 10: Photograph of low-rise building B-12 showing the exterior of unit 115 at the rear façade, facing southwest, with smoke damage at the windows and eaves. Source: MHA, received by ICF on 5/19/2020.**

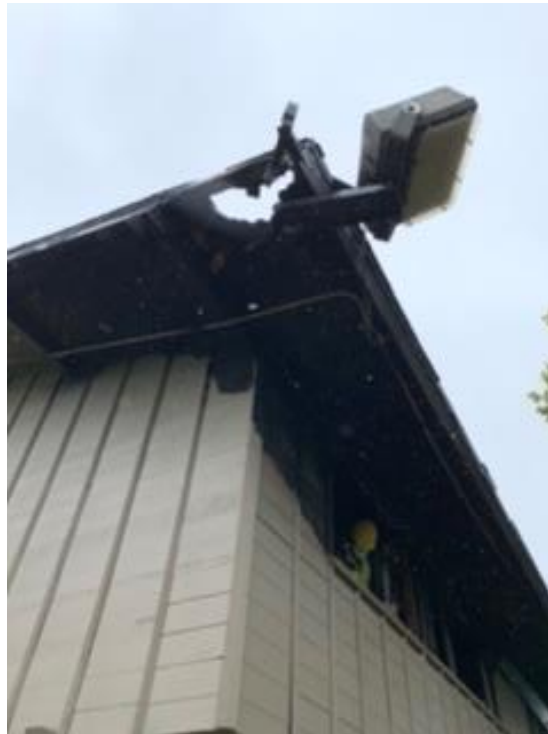
**Figure 11: Photograph of building B-12 showing the exterior of unit 115, roof and siding damage at the primary (west) and north façades, facing southeast. Source: MHA, received by ICF on 5/19/2020.**
