# **FINDING OF EFFECT MEMORANDUM (Revised)**

*Prepared by ICF at the request of Marin Housing Authority in partial fulfillment of Section 106  
Review requirements*

**July 14, 2020**

**Historic Property:** Golden Gate Village  
**Project Name:** 115 Drake Avenue Repair  
**Street Address:** 101–429 Drake Avenue and 1–99 Cole Drive, Marin City  
**Project Applicant:** Marin Housing Authority, County of Marin  
**Lead Agency:** County of Marin  
**Project Contact:** Evan Smith, esmith@marinhousing.org

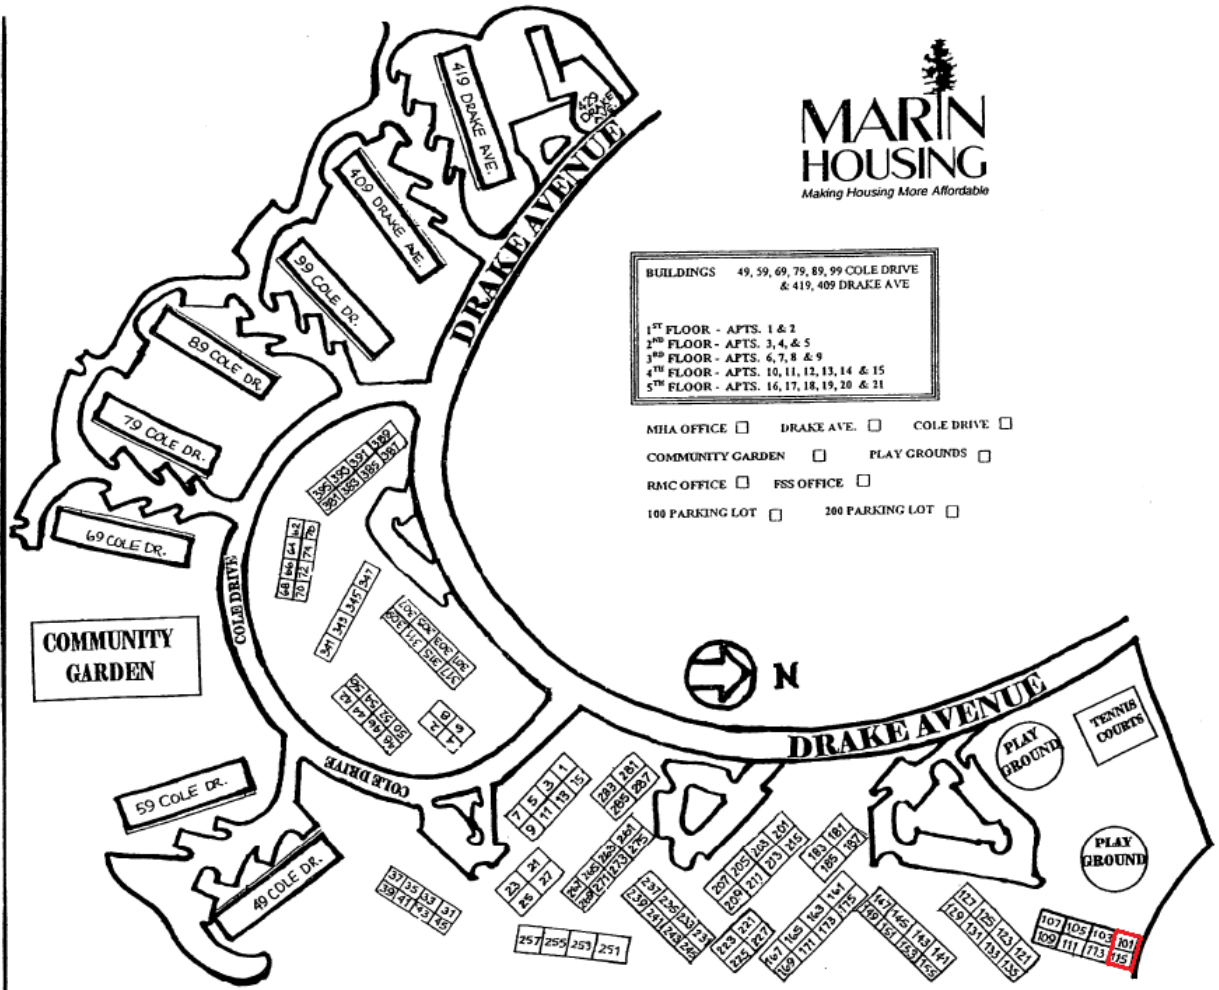
In April 2020 a fire occurred within unit 115 (address: 115 Drake Avenue) on the second floor of building B-12 in GGv. A site plan is included below to illustrate the layout of the complex and building names (Figure 5). Unit 115 in Building B-12 is outlined in red. The repairs will be primarily located at the building's north end, near GGv's north boundary, and at the primary façade at the northwest corner, near the play area to the west (Figure 6), and at the rear façade at the northeast corner near the landscaped slope adjacent to U.S. Highway 101 to the east (Figures 7 and 8). Because the fire did not damage the first floor, all work will be limited to the second story and roof, and no ground disturbance will occur as a result of this undertaking.

Figure 5: A site plan illustration of GGV. North is right, Highway 101 is to the east; not to scale. Unit 115 is outlined in red, which is on the second story above unit 101. Courtesy: MHA, with illustration by ICF.

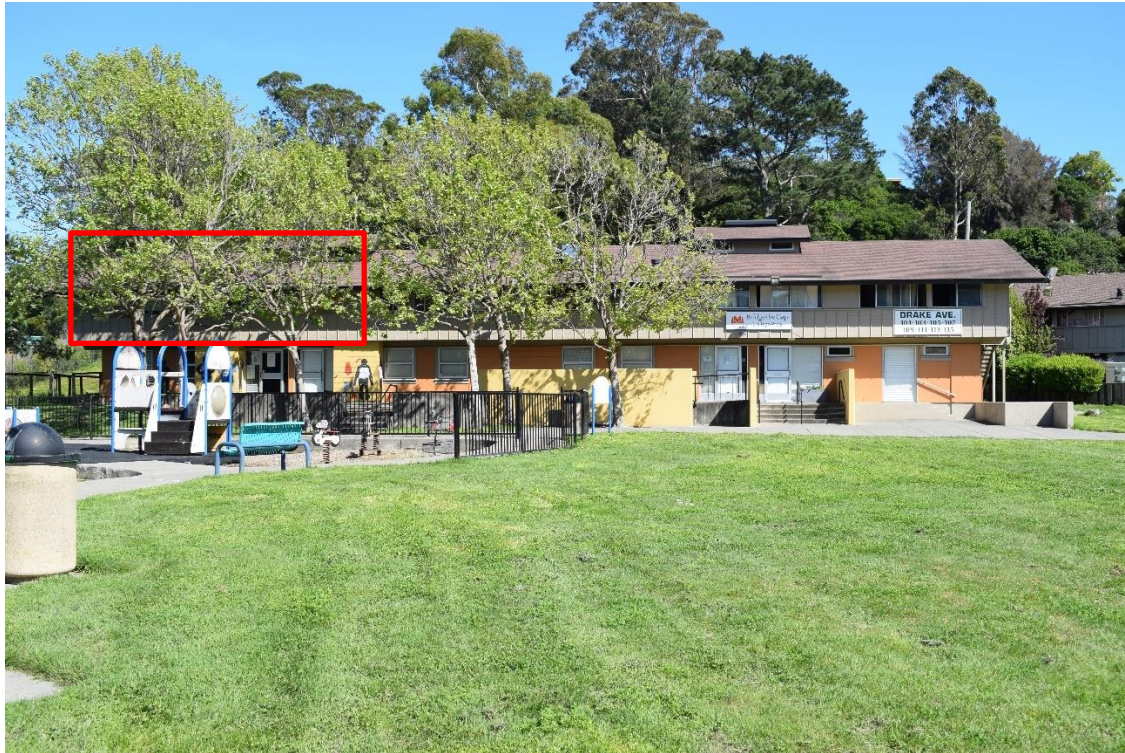
**Figure 6: Photograph of low-rise building B-12, primary (west) façade, with approximate location of unit 115 outlined in red, facing east. Source: ICF, 4/10/2019.**

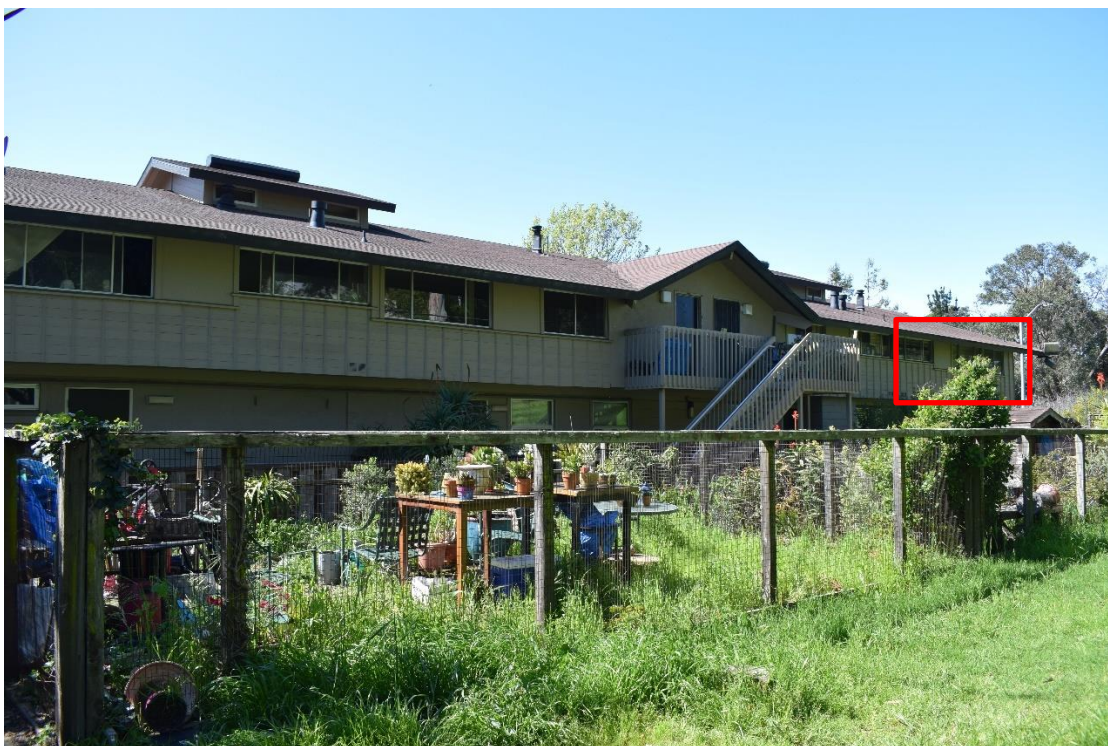
**Figure 7: Photograph of low-rise building B-12, rear (east) façade, with approximate location of unit 115 outlined in red, facing northwest. Source: ICF, 4/10/2019.**

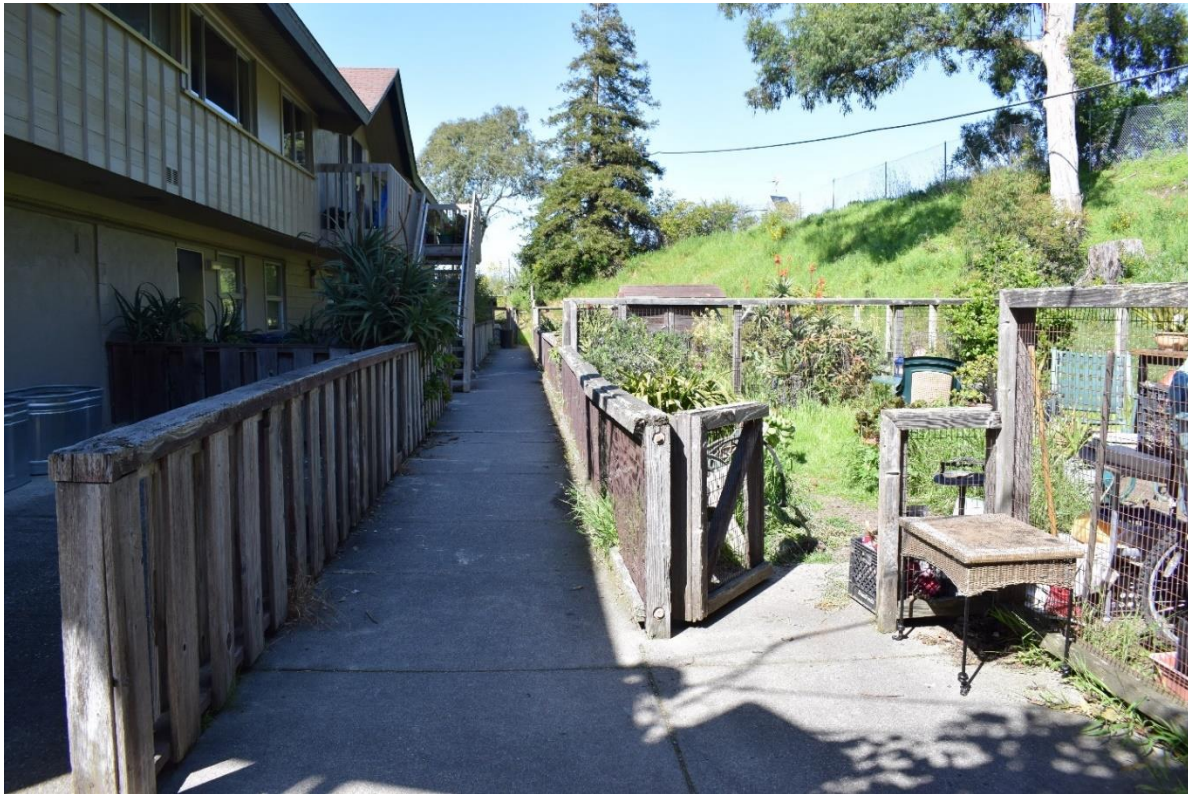
**Figure 8: Photograph of low-rise building B-12, rear (east) façade to the left and sloped landscape to the right, facing north. Source: ICF, 4/10/2019.**
