FINDING OF EFFECT MEMORANDUM

Prepared by ICF at the Request of the Marin Housing Authority

December 2020

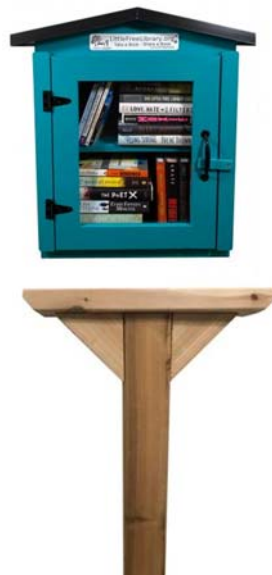
Figure 1. Representation of the lending library that would be placed on the property. Source: MHA, June 2020.

- The placement of one new lending library on the property, known as the Little Free Library, would enable GGV residents to donate and/or borrow books from other residents. The structure would be a two-shelf shed mounted on top of a wood post (Figure 1). The library’s dimensions would be 22.5 inches tall by 14.5 inches long by 17 inches wide, with overhanging eaves (1 inch) on all four sides of the library. The wood post would be 4 inches by 4 inches by 60 inches, with a mount between the post and library that would be 15 inches by 5 inches. The location for the lending library has not yet been determined. Potential locations are discussed below, under section **VI. Finding of Effect**.

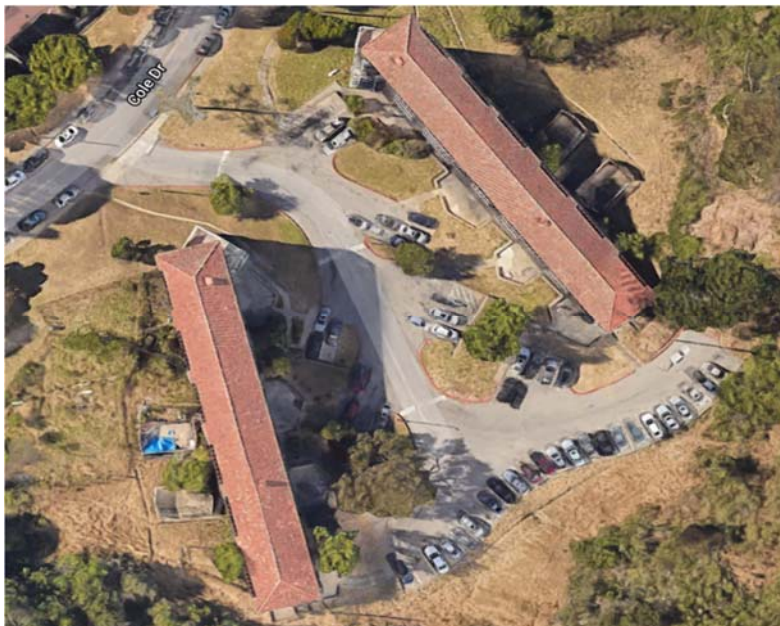
Figure 3. Aerial view of one of the terraced driveways in the high-rise cluster along Cole Drive (north is up). Source: Google, 2020.

- Repainting the existing parking lot stripes throughout the property. Restriping would take place in every parking lot in GGV, which includes five triangular parking lots within the low-rise cluster (Figure 2) and four driveways with parking terraces in the high-rise cluster (Figure 3), but would not change the existing parking configurations.

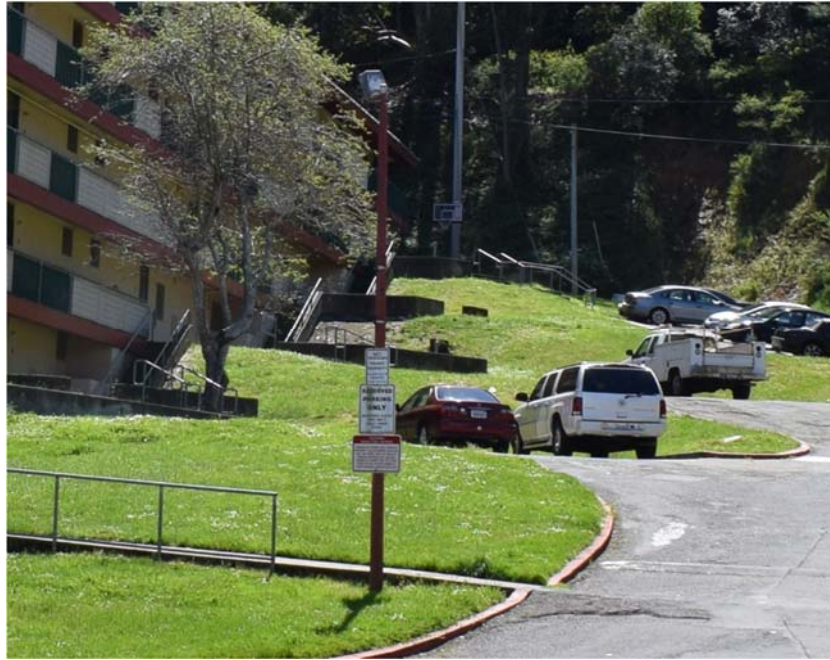
Figure 5. Representative example of the 20-foot Specific Area lighting standard in the parking area near the high-rise building at 89 Cole Drive, facing south. Source: ICF, April 2019.

1. Two types of Specific Area lighting units (historic, altered):
 - i. Type 1.i, located within the parking areas, comprises pedestal-mounted, 20-foot metal poles with either hand holes or a box with a gasket and cover near the base. The tops of the light standards have either one or two flat, rectangular light fixtures. Those with two lights have two metal poles that extend outward, each supporting a light fixture; some of these standards have security cameras and metal electrical boxes immediately below the light fixtures and/or signage attached closer to the base (Figures 5 and 6).

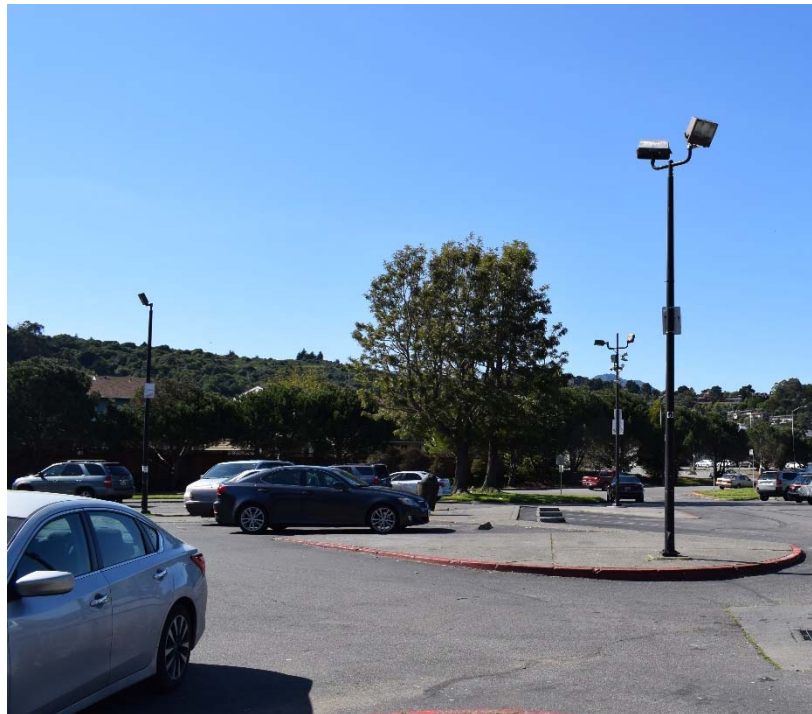
Figure 6. Representative examples of the 20-foot Specific Area lighting standards within a triangular lot in the low-rise cluster, facing northwest, toward Drake Avenue. Source: ICF, April 2019.

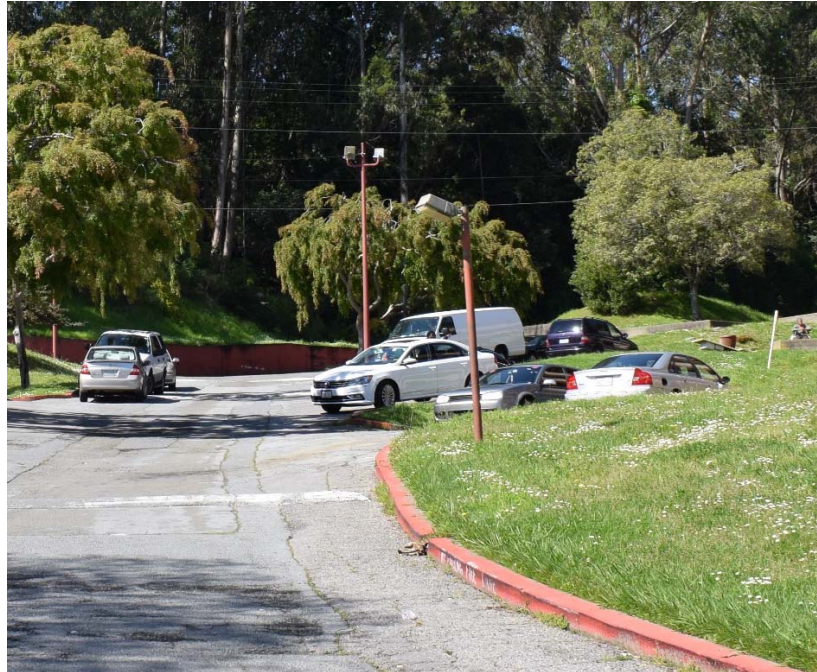
Figure 7. Representative example of a 12-foot Specific Area lighting standard in the foreground. Source: ICF, April 2019.

- ii. Type 1.ii is represented by a single light standard in the parking lot for the high-rise cluster. The 12-foot metal pole has a box with a gasket and cover near its base.¹ The top of the light standard contains one flat, rectangular light fixture (Figure 7).

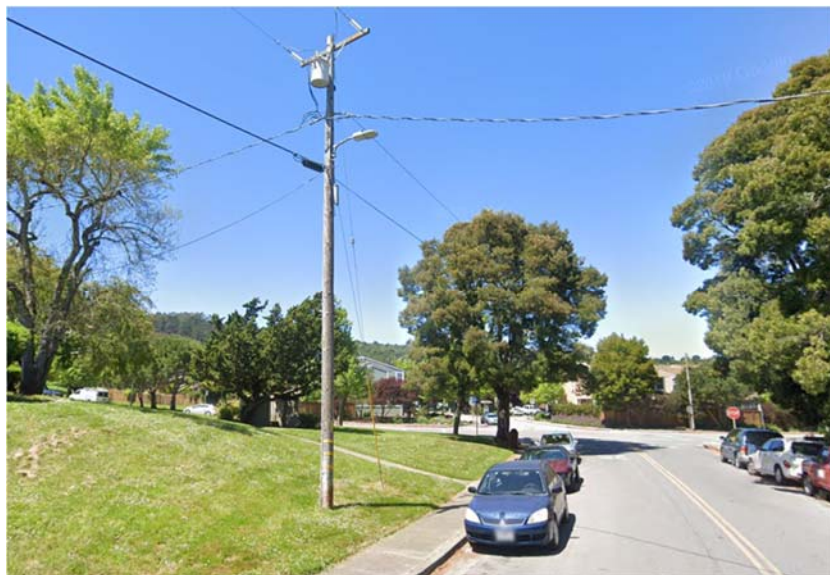
Figure 8. Single utility pole light standard, composed of an extension arm on a utility pole, located along Cole Drive, facing northwest. Source: Google, April 2019.

2. Utility pole light standards:
 - i. This type includes a metal extension arm and fixture attached to wooden utility poles. The fixture has a single contemporary LED light (Figure 8). One example of this light standard is within the APE and maintained by Marin County.² Additional utility poles are located along the service road on the south edge of the high-rise buildings, though it appears that they do not include light fixtures.

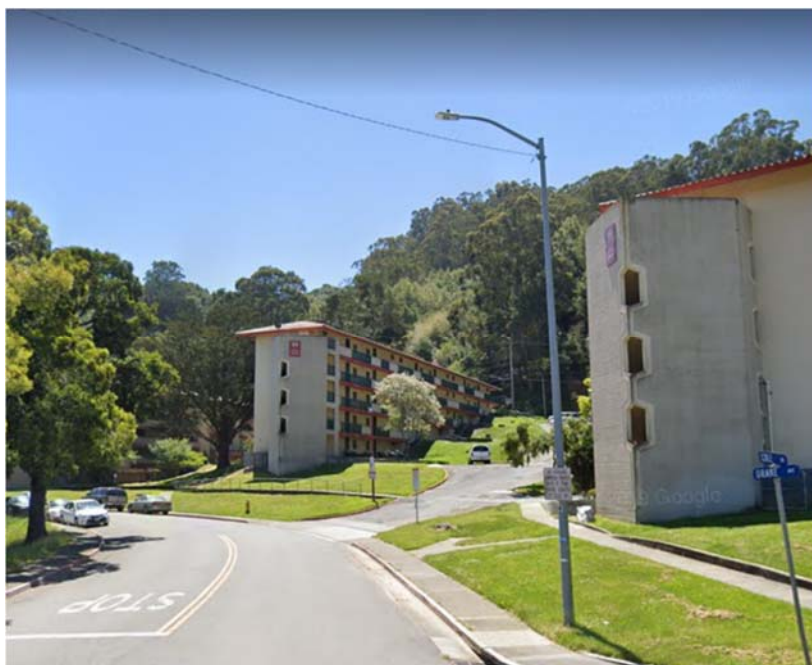
Figure 9. Single contemporary light standard on Cole Drive at Drake Avenue, facing south. Source: Google, April 2019.

3. Contemporary light standards:
 - i. These standards are composed of a pedestal-mounted metal pole with a metal extension arm that supports an LED light (Figure 9). One example of this type of light standard is located on Cole Drive at Drake Avenue. Additional contemporary light standards are located along Drake Avenue, adjacent to but outside the historic property boundary. These light standards appear to be maintained by Marin County, based on information from the Marin County online map portal.³

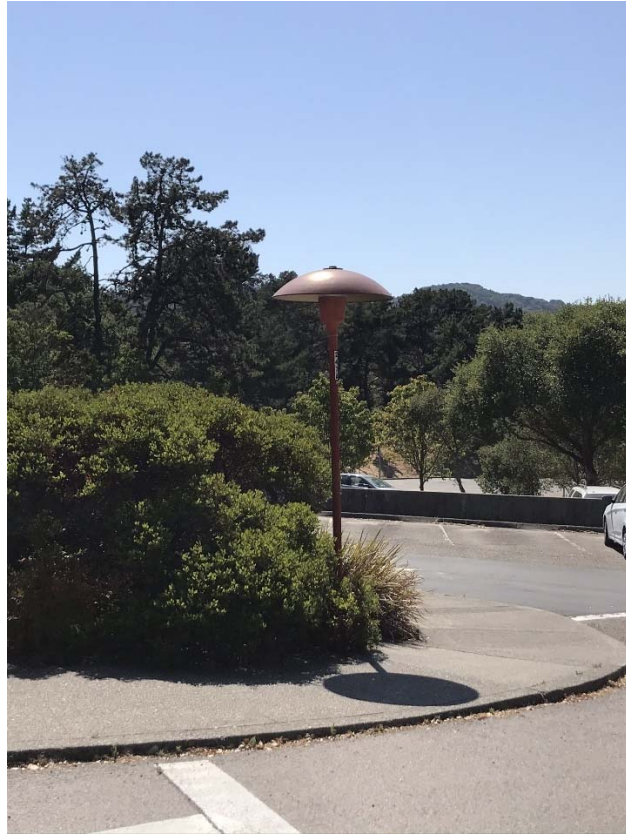
Figure 11. Example of a light standard with a similar rounded hood outside GGV in the Marin County Civic Center, in an area where architect Aaron Green was on the original design team. Source: ICF, 2020.

The 1958 exterior electrical distribution site plans reveal that the type 1.i light standards originally included rounded hoods (Figures 10 and 11). At an unknown date, the rounded hoods were removed and replaced with either one or two flat, rectangular light fixtures. The same plans also indicate that the type 1.i light standards originally contained hand holes near the base. It appears that some of the hand holes were replaced or covered by a box with a gasket and cover at unknown dates. Security cameras and metal electrical boxes as well as signage have also been added to some type 1.i light standards.

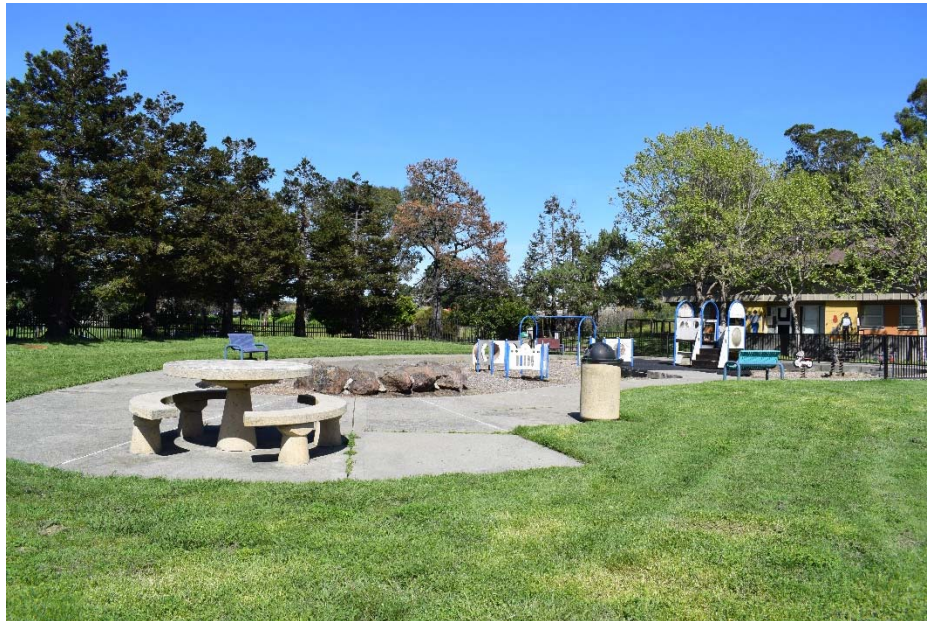
Figure 14. Potential area where the lending library could be inserted on the property. View is looking northeast, toward the play area near GGV’s east boundary. Source: ICF, April 2019.

The location of the lending library requires some consideration. It would be appropriate to place the new feature within an already-disturbed area of GGV so that it would not affect the character-defining features of the historic property. Suitable locations may include sites within the recreational cluster or at the community garden (Figures 14 and 15). Neither area is historic and neither would be affected through insertion of a new small-scale feature.
